### Silver Lake 2023 Aquatic Vegetation, Water Quality, and 2023 Management Recommendations Report with Biochar Efficacy Results

November, 2023

# Silver Lake 2023 Aquatic Vegetation, Water Quality, and 2024 Management Recommendations Report with Biochar Efficacy Evaluation

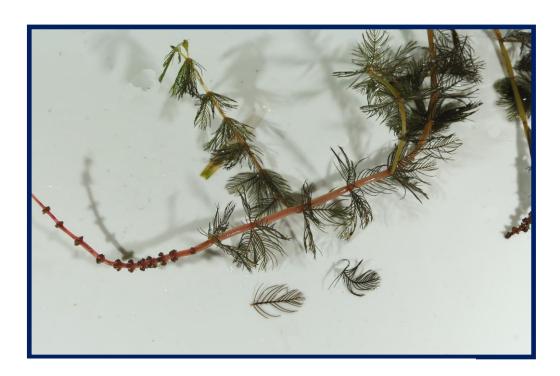
The amount of Eurasian Watermilfoil (Figure 6) present in Silver Lake varies each year and is dependent upon climatic conditions, especially runoff-associated nutrients. The June 20, 2023 survey revealed that approximately 5 locations of milfoil were found throughout the entire lake at the "a" or low abundance level. In addition, there was the presence of another invasive species, Curlyleaf Pondweed (Figure 7) which was found in 13 locations within the lake at the "a" and "b" low abundance levels. Currently, both invasives are welcomed habitat for the fishery but are being monitored for any aggressive invasion or Figure 8 shows the current biovolume of submersed aquatic vegetation in the lake which is still low but higher than in previous years. It must continue to increase to assist in the reduction of blue-green algae in the lake, as this algae competes with submersed aquatic vegetation for nutrients. The clarity of the lake has been reduced by runoff, blue-green algae, and bottom-feeding carp but these issues are being addressed and the water clarity is improving and should continue to improve. No treatments were needed in 2020-2023 due to lack of milfoil growth and the need for some vegetative cover. The MDNR report (2020-001) by Mark A. Tonello recommended no further treatments at this time. RLS agrees with this recommendation; however, if milfoil is determined to be an imminent threat to the ecology of Silver Lake through development of dense beds that form canopies that may fragment, then RLS will recommend management of those localized beds to reduce the threats of spreading. RLS will carefully monitor the lake again next year for any possible invasions.

Figure 6. Eurasian Watermilfoil (Myriophyllum spicatum)

Continuous whole-lake aquatic vegetation surveys are needed to determine the precise locations of EWM and other problematic invasives in and around Silver Lake. These surveys should occur in late-May to early-July and again post-treatment (if needed) in 2024. If treatments are needed, RLS scientists will be present to oversee all aquatic herbicide treatments. It must again be stated that treatments of milfoil will only be recommended if the milfoil beds are an imminent threat to Silver Lake. RLS has discussed planting of native aquatic plant species in Silver Lake which may be permitted in the near future if water clarity improves to allow for successful germination and acceptable biomass does not naturally grow. In 2023, the relative abundance of many favorable native aquatic plants was higher, and this is an encouraging outcome from recent improvements.

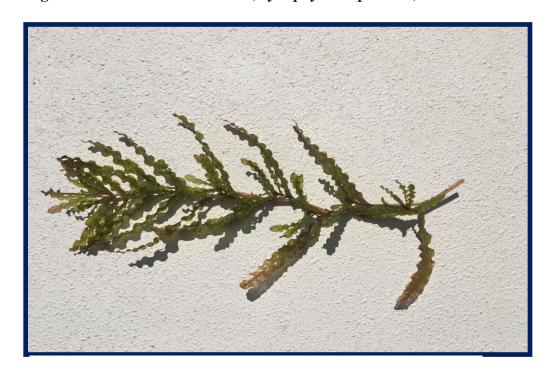
Figure 7. Curly-leaf Pondweed (Potamogeton crispus)

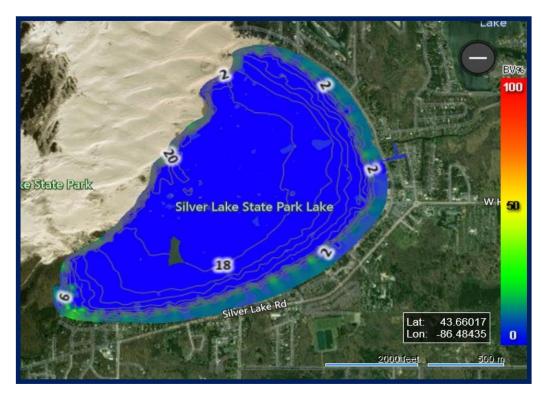
Figure 8. Aquatic Vegetation biovolume in Silver Lake (June 20, 2023).
